AMD-K6™

MMX™ Enhanced Processor

Revision Guide

Publication # 21266	Rev: F	Amendment/0
Issue Date: September 1997

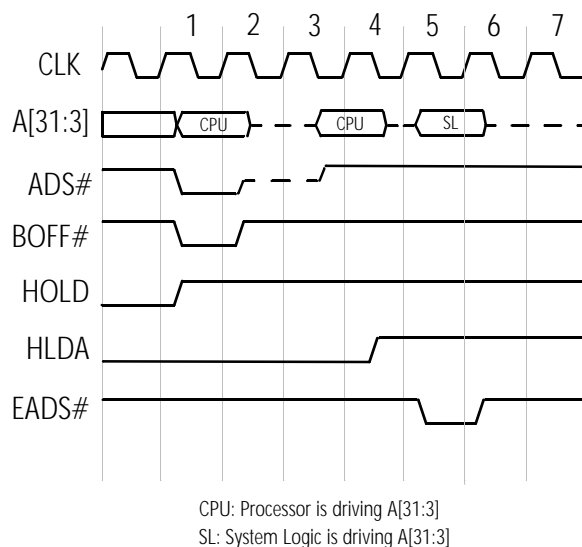
Figure 1. AMD-K6™ Processor Assertion of **HLDA** Due to Simultaneous **BOFF#**/**HOLD** Assertion

Normal Specified Operation. If **BOFF#** and **HOLD** are sampled asserted on the same clock edge that negates **ADS#**, the processor asserts **HLDA** one clock edge after **HOLD** is sampled asserted.

Non-conformance. If **BOFF#** and **HOLD** are sampled asserted on the same clock edge that negates **ADS#**, the processor asserts **HLDA** two clock edges after **HOLD** is sampled asserted.

- If the system logic asserts **BOFF#** for a duration of one clock, anticipates the assertion of **HLDA** in clock 3 (see Figure 1)—which is the normal specified operation—and drives the address bus and **EADS#** for an inquire cycle in clock 3, then the processor will not sample **EADS#** asserted. In addition, address bus contention will occur in clock 3.

- If the system logic asserts **BOFF#** for a duration of two clocks, anticipates the assertion of **HLDA** in clock 3, and drives the address bus and **EADS#** for an inquire cycle in clock 3, then the processor will not sample **EADS#** asserted. (No address bus contention occurs in this case.)

- If the system logic asserts **BOFF#** for a duration of one clock, anticipates the assertion of **HLDA** in clock 3, and drives the address bus and **EADS#** for an inquire cycle in clock 4, then address bus contention may occur in clock 4. (The processor will sample **EADS#** asserted in this case.)

If the processor does not sample **EADS#** asserted during an inquire cycle, cache/memory incoherency will occur. Address bus contention can affect the reliability of the processor and the system logic.

Suggested Workaround. The system logic must sample the assertion of **HLDA** before asserting **EADS#** and driving the address bus for an inquire cycle—as shown in clock 5 of Figure 1.
